TR-189

TECHNICAL REPORT

OCEAN BOTTOM RECONNAISSANCE OFF THE  
EAST COAST OF ANDROS ISLAND, BAHAMAS

The survey was performed to provide information applicable to the installation of submarine cables in support of the U. S. Navy's Atlantic Undersea Test and Evaluation Center.

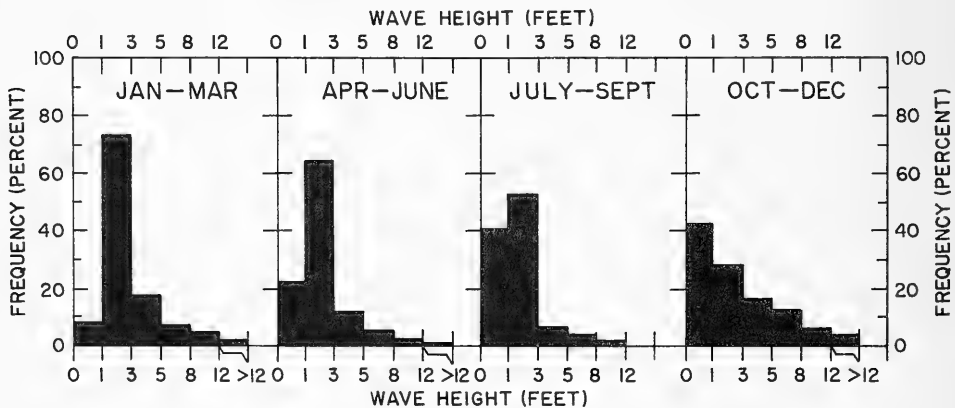
FIGURE 4. OBSERVED SEASONAL WAVE HEIGHTS, DIRECTION AND FREQUENCY IN THE TONGUE OF THE OCEAN.

In the Tongue of the Ocean, theoretical wave heights of 11.3 feet can be generated at a wind speed of 26 knots. DeLeonibus (1960) presented Figure 4 which represents observed seasonal wave heights, direction, and frequency in the Tongue of the Ocean. From the same report (*Ibid*) Table 3 summarizes the most probable wave heights from all directions for wind speeds ranging from 10 to 26 knots under unlimited duration at the downwind edge of the fetch.

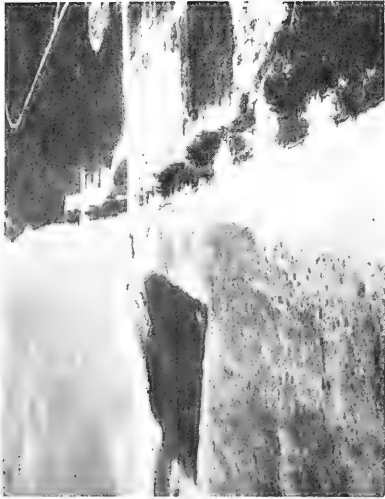
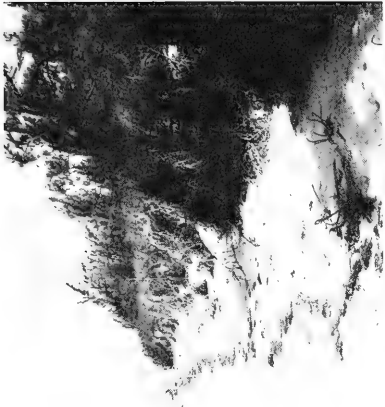
PLATE 2. FRESH CREEK BARRIER REEF (A) AS VIEWED FROM LAGOON, DEPTH 5 FEET, (B) ACROPORA PALMATA AWASH AT LOW TIDE, (C) OUTER PLATFORM ADJACENT TO BARRIER REEF, DEPTH 8 FEET, (D) OUTER PLATFORM BETWEEN 40 AND 60 FEET DEEP.

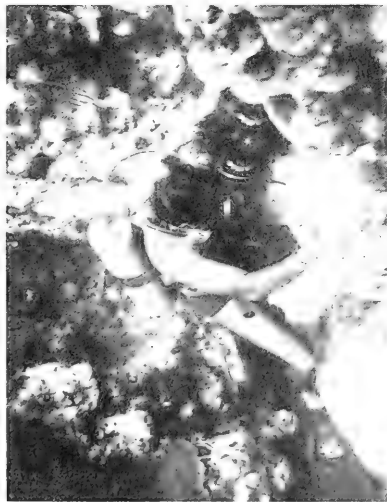
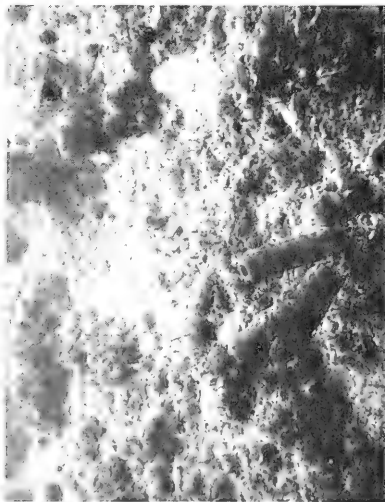
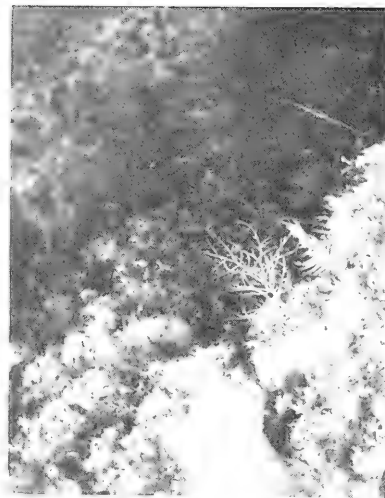
PLATE 3. FRESH CREEK (A) ONE OF THE BLIND CHANNELS IN THE ZONE OF LUXURIANT CORAL GROWTH BETWEEN 40 TO 60 FEET DEPTH, (B) OUTER PLATFORM, DEPTH 110 TO 130 FEET, (C) DETAILED VIEW OF OUTER PLATFORM SHOWING HARD BOTTOM AND THIN SAND VENEER, (D) VERTICAL DOWNWARD VIEW OF EDGE OF OUTER PLATFORM AT 130 FEET. NOTE TERRACE TO RIGHT OF PHOTOGRAPH APPROXIMATELY 15 FEET DEEPER.

100 to 120 feet in depth the hard outer platform departs from its gentle seaward slope. There it assumes a dip between 30° and 40° which terminates at 120 feet where a terrace approximately 150 feet wide extends to 130 feet depth at the top of the rim escarpment (Plate 3). The face of this escarpment is discussed on page 24.

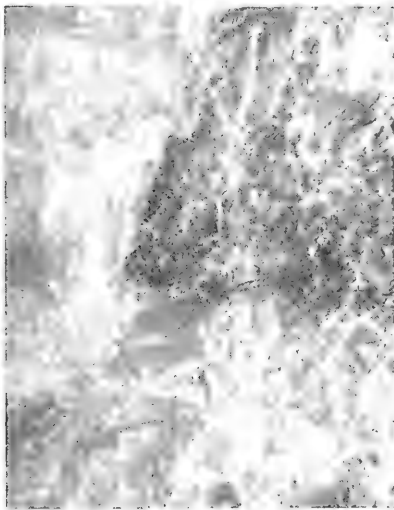
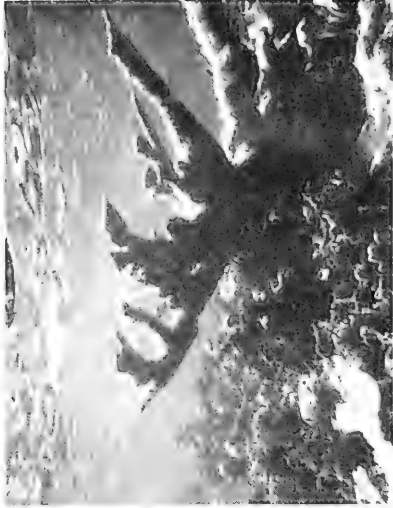
PLATE 6. SALVADOR POINT (A) & (B) PATCH REEF, BUOY 8, DEPTH 3 FEET. (C) BARRIER REEF ON LAGOON SIDE, AND (D) SEAWARD SIDE. DEPTH 5 FEET. LARGE CORAL IN FOREGROUND IS ACROPORA PALMATA.

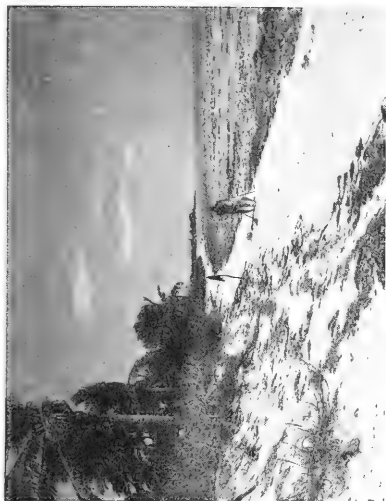
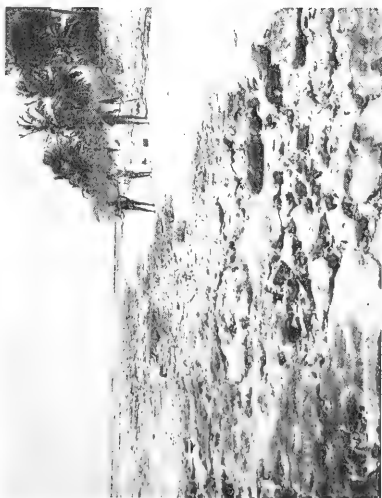
PLATE 8. BIG WOOD CAY (A) LOW TIDE TERRACE VIEWED SHOREWARD, (B) TERRACE TIDE POOL WITH SEA URCHINS, (C) & (D) LAGOON BOTTOM BETWEEN BUOYS 1 TO 4, DEPTH 4 FEET (LOW TIDE).

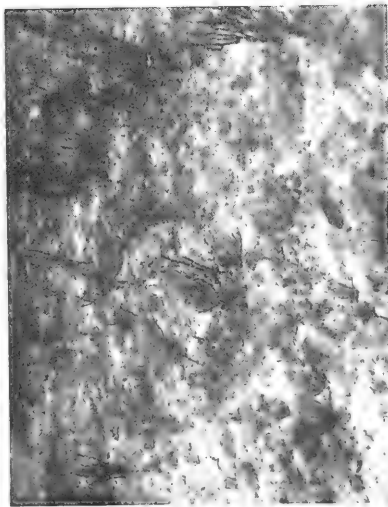
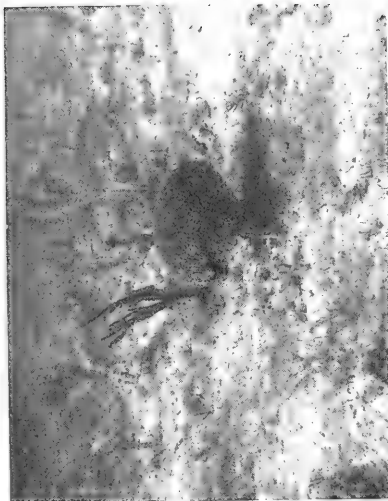
PLATE 9. BIG WOOD CAY (A) LAGOON BOTTOM BETWEEN BUOYS 1 TO 4, DEPTH 4 FEET (LOW TIDE), (C) & (D) LAGOON BOTTOM AT BUOY 5, DEPTH 5 FEET. ROUNDED CORAL (DIPLOPIA CLIVOSA) IS 1 FOOT ACROSS.

The lagoon bottom between Big Wood Cay and the offlying reef varies substantially from the bottom off Salvador Point. Here the bottom consists of hard, eroded, and fractured rock which supports numerous and varied organisms. Sea fans and whips dominate the area and scattered coral heads provide relief of from 1 to 2 feet. Plates 8 and 9 are typical of the bottom throughout the lagoon. Lack of a thick sand covering and marine grasses indicates strong water circulation. Circulation is periodic and controlled by the ebb and flood of the tide in the channel between Gibson and Big Wood Cays where a current speed of 1 knot can be observed.

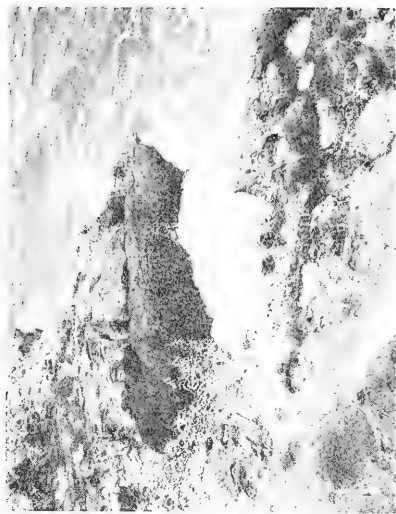
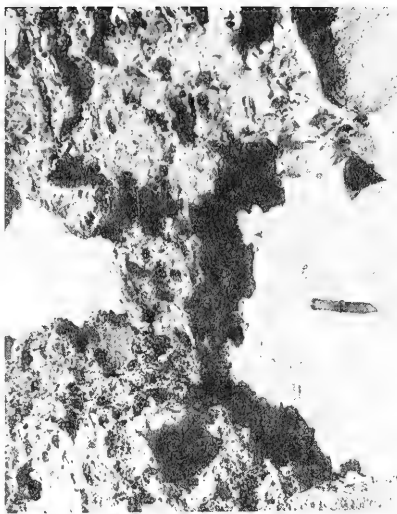
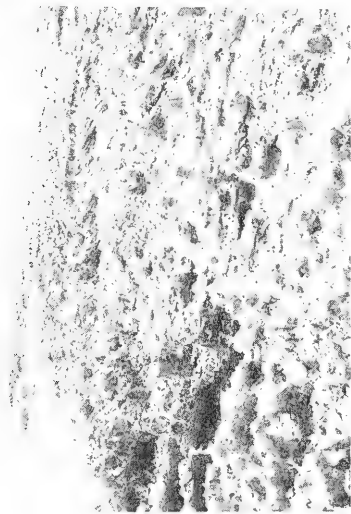
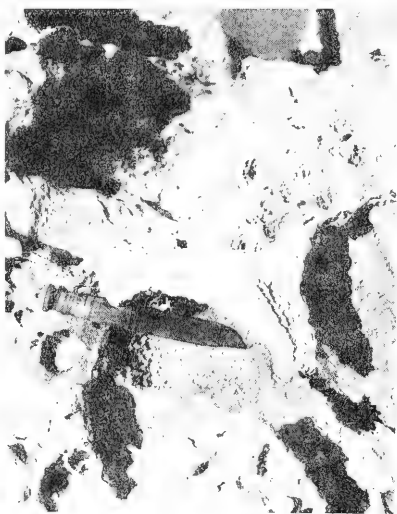
PLATE 12. GOLDING CAY (A) & (B) EASTERN SHORELINE, (C) & (D) DETAILED VIEW OF CAY ROCK. KNIFE IS 8 IN. LONG.

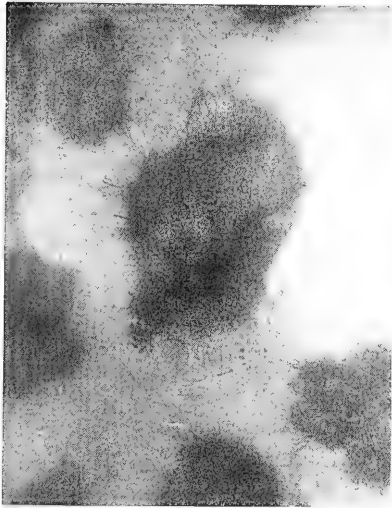
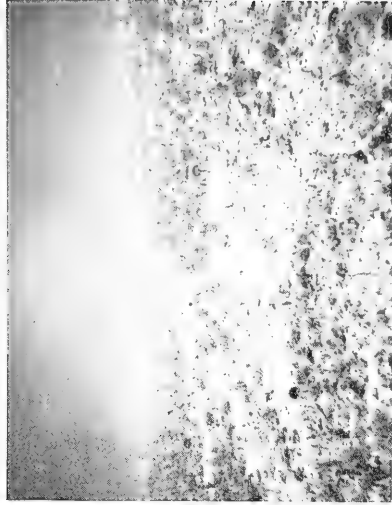
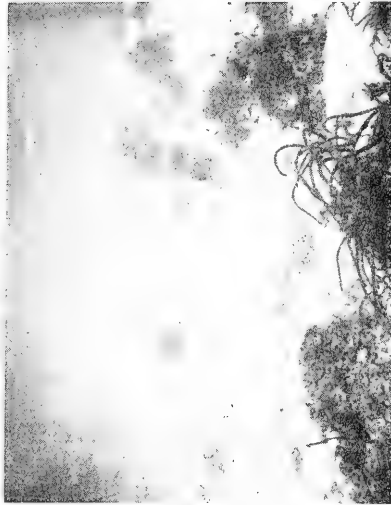
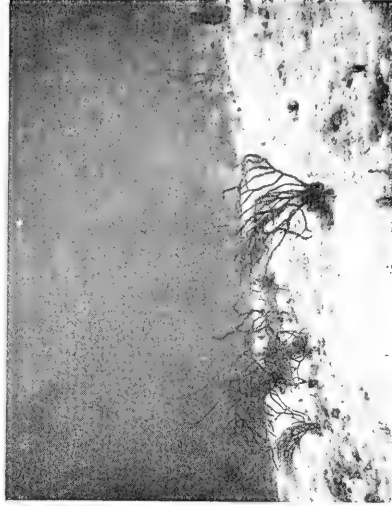
PLATE 14. GOLDING CAY (A) BOTTOM AT BUOY 8, DEPTH 45 FEET. HEADS ARE 3 TO 5 FEET HIGH AND 6 TO 8 FEET ACROSS. (B) & (C) BOTTOM BETWEEN BUOYS 9 AND 11, DEPTH 50 TO 60 FEET. (D) BOTTOM BETWEEN BUOYS 11 AND 12, DEPTH 120 FEET.

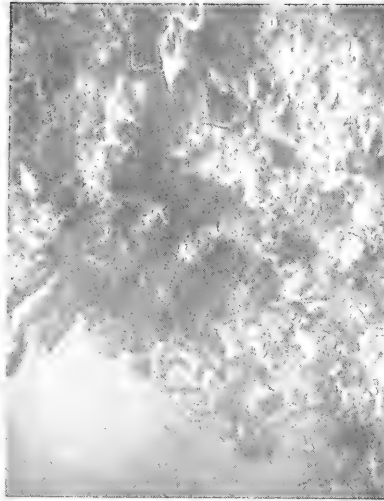
D

PLATE 15. GOLDING CAY (A) LARGE CORAL HEAD AT 125 FEET DEPTH DOMINANTLY COMPOSED OF MONTASTREA CAVERNOSA. (B) & (C) OBLIQUE VIEW DOWN RIM ESCARPMENT FROM EDGE OF OUTER PLATFORM. (D) VIEW ALONG WALL OF RIM ESCARPMENT, DEPTH 130 FEET.

Between Golding Cay and the rim escarpment, the sea bottom supports a luxuriant and varied community of organisms. From the shore to approximately 1,500 yards seaward, the bottom is hard, rough, and covered with coral heads as much as 10 to 15 feet in height and diameter (Plate 13). Locally, ripple-marked, sandy areas separate the heads (Plate 13D). Approximately 1,400 yards from shore, the virtually continuous coral growth breaks into isolated clumps separated by areas of coarse sand. Beyond this to the break-in-slope, a barren sand with scattered gorgonians and soft green algae prevails (Plate 14). The outer platform edge displays an increase in organisms and a rough, hard surface (Plate 15).

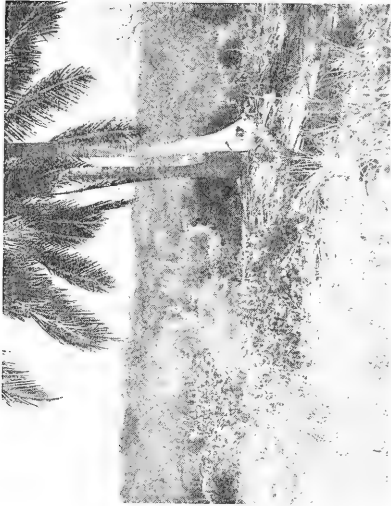
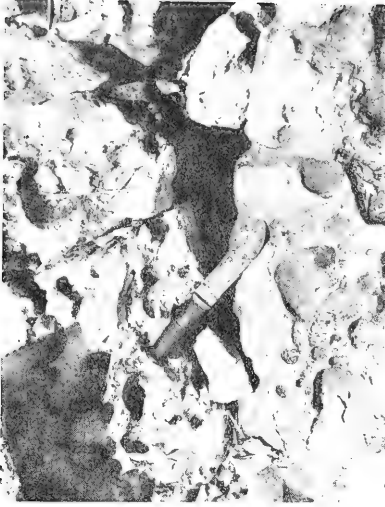
PLATE 16. DEEP CREEK (A) BACKSHORE AREA. (B) DETAILED VIEW OF COUNTRY ROCK. KNIFE IS 8 INCHES LONG. (C) & (D) VIEWS OF BEACH FACE.

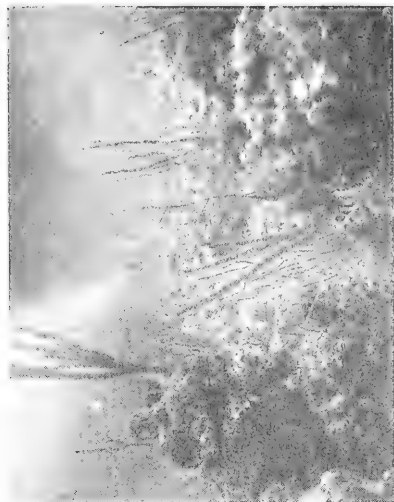
B

PLATE 18. DEEP CREEK (A) GRASS AND SAND BOTTOM AT BUOY 10, DEPTH 11 FEET. (B) SEAWARD OF SAND-GRASS AREA SHOWING HARD, ROUGH BOTTOM, DEPTH 15 FEET. (C) & (D) OUTER PLATFORM SPURS AND GROOVES AND ISOLATED HEADS, DEPTH 30 FEET. BUOY 11.

At Buoy 10 (1.6 miles from shore) a dense growth of grass appears which gradually transcends seaward into corals and other organisms (Plate 18). Buoy 10 is at the approximate location of the barrier reef. The reef is not well-developed along this track, and no distinct change in bathymetry marks its boundaries. Seaward of Buoy 10 dense coral growth dominates, and assumes the same pattern as at Golding Cay, e.g., isolated heads and sand areas. This pattern continues to the rim escarpment.

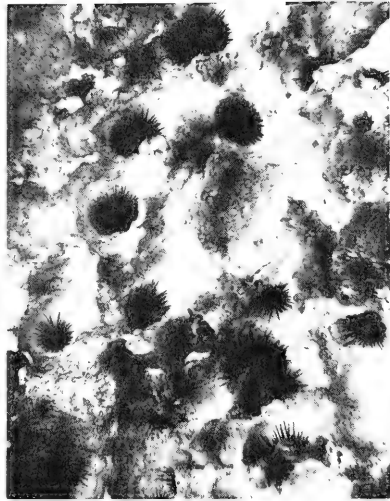
PLATE 19. HIGH POINT CAY: (A) AND (B) NORTH SIDE OF CAY, BLUFFS 15-20 FEET HIGH. (C) UNDERCUT BLUFFS, WATER DEPTH 6 FEET. POLE IS MARKED AT 1 FOOT INTERVALS. (D) DETAILED VIEW OF WALL AT UNDERCUT SHOWING ROUGH, ANGULAR SURFACE AND SEA URCHINS.

At this point the elevation is 47 feet and the shoreline descends almost vertically to a depth of 5 feet below mean low water. The base of the shoreline below water level is undercut approximately 4 feet and is thoroughly pitted with small angular cavities (Plate 19).

A sketch showing the major features and their depth of occurrence is presented in Plate 24 which is a composite representation of the wall as derived from data collected on all dives. Regionally, little difference is present in the rim characteristics at all four locations. The spur and groove configuration which is distinct and extends to the break-in-slope at dive location 1 is less distinct at dive 2 and not present at dives 3 and 4. Also present at dive 1 is a well-defined notch in the wall which commences at 170 feet and ends abruptly at 200 feet. This notch is continuous for more than 100 yards on both sides of the survey line and penetrates in excess of 20 feet into the wall. On the remaining dives no well-defined notch was observed. The similarity of this notch to the intertidal notches observable at the base of present day Bahamian cays and islands is striking, (see Plate 19C of High Point Cay) and strongly suggests formation at a previous lower sea level.

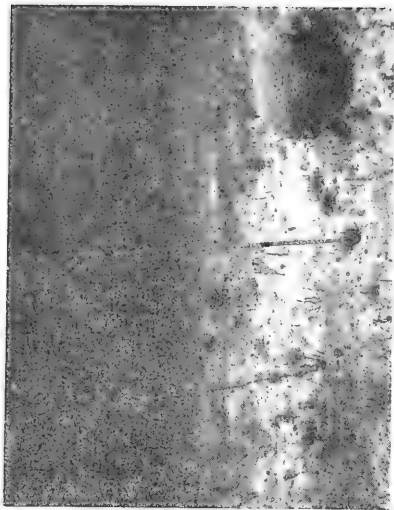
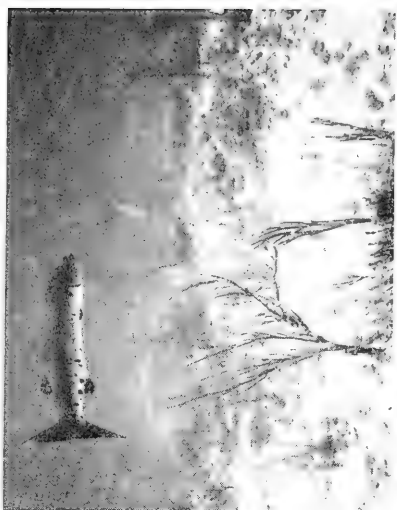
PLATE 20. HIGH POINT CAY (A) & (B) BUOY 3, DEPTH 12 FEET. CORAL IN (B) IS DIPLOPIA LABRYNTHIFORMIS. (C) & (D) BUOY 4, DEPTH 15 FEET.

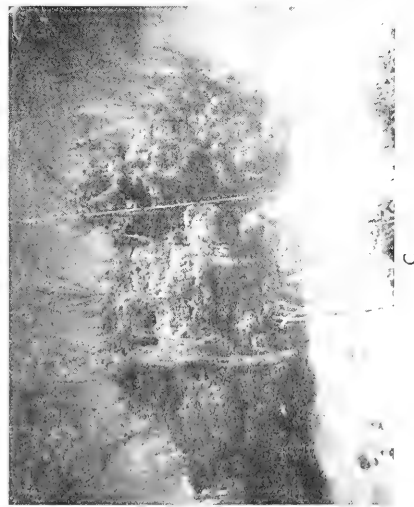
PLATE 21. HIGH POINT CAY (A) & (B) BUOY 7, DEPTH 24 FEET. THIN SAND VENEER OVER HARD ROCK. (C) & (D) BUOY 9, DEPTH 30 FEET. COMMENCEMENT OF LARGE HEADS AND IRREGULAR BOTTOM TOPOGRAPHY.

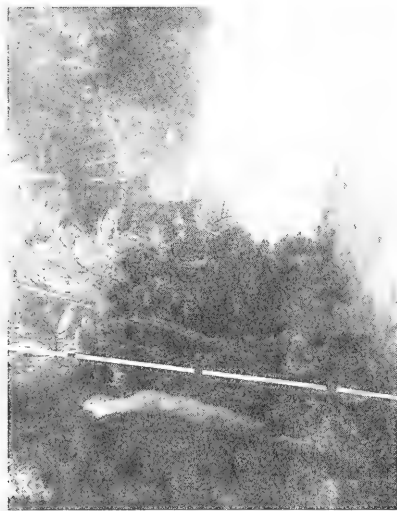
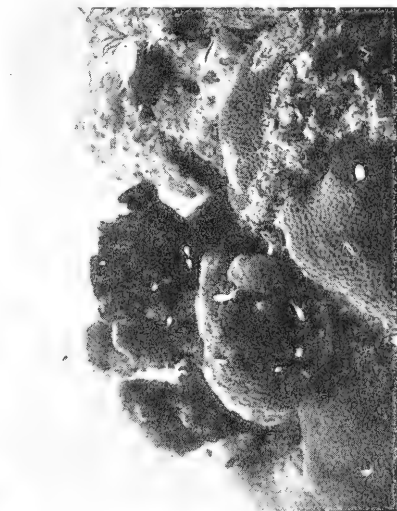
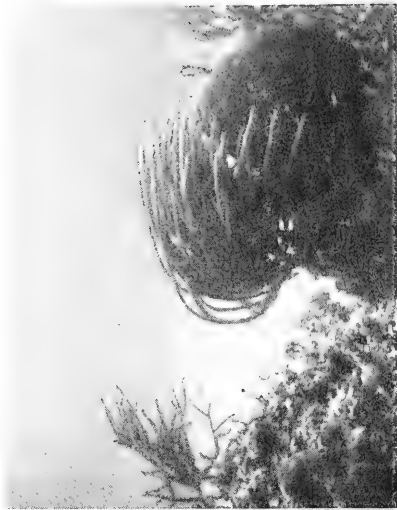
PLATE 22. HIGH POINT CAY (A) & (B) BUOY 10, DEPTH 37 FEET. (C) BUOY II, DEPTH 60 FEET. (D) SEAWARD OF BUOY II, DEPTH 90 FEET.

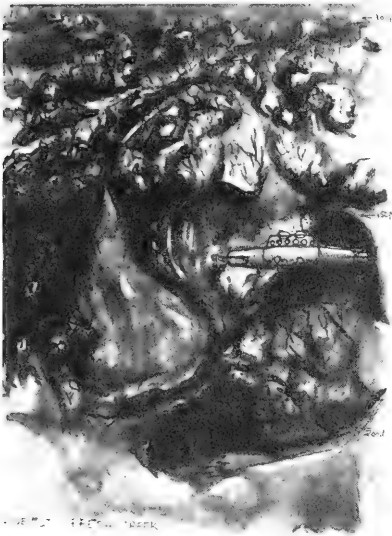
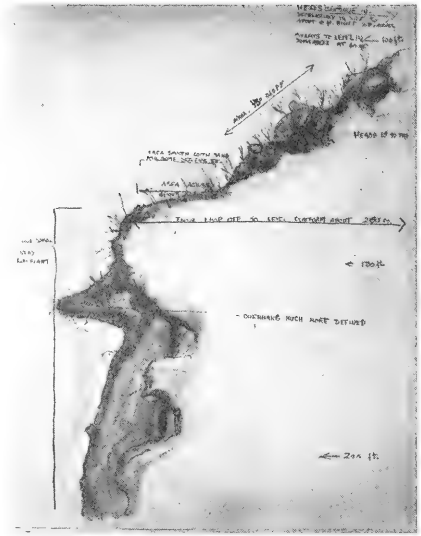
PLATE 25. TONGUE OF THE OCEAN, DRAWINGS SHOWING MAJOR FEATURES OF RIM ESCARPMENT. (A) CORES, TERRACES AND SAND FLOWS BETWEEN 130 AND 450 FEET. (B) PROFILE OF SAME AREA SHOWN IN A. (C) ESCARPMENT AND CABLES OFF BIG WOOD CAY. (D) SHOWING THE SMOOTHER NATURE OF THE EXCARPMENT BELOW 450 FEET.

| 55 | Plate 25(A) | Read: "CAVES" for<br>"CORES" |
| | Plate 25(D) | Read: "ESCARPMENT" for<br>"EXCARPMENT" |

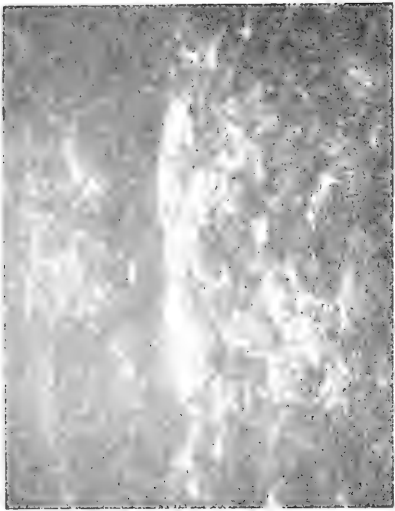
PLATE 26. REPRESENTATIVE PHOTOGRAPHS OF MARGINAL ESCARPMENT OFF GOLDING CAY. (A) 210 FEET. (B) 242 FEET. (C) 270 FEET. (D) 312 FEET.

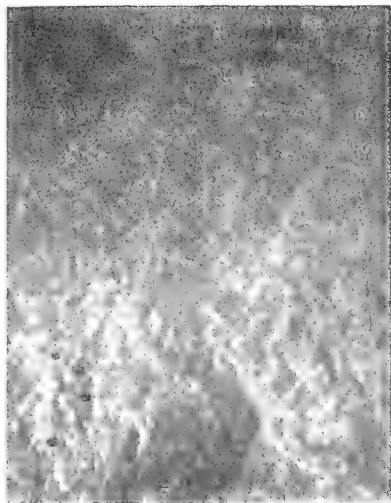
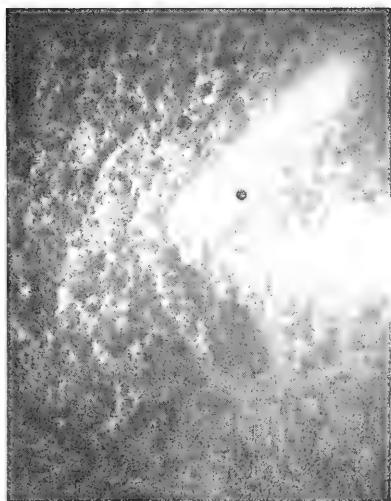
PLATE 27. REPRESENTATIVE PHOTOGRAPHS OF MARGINAL ESCARPMENT OFF GOLDING CAY. (A) 343 FEET. (B) 349 FEET. (C) 447 FEET. (D) 450 FEET.

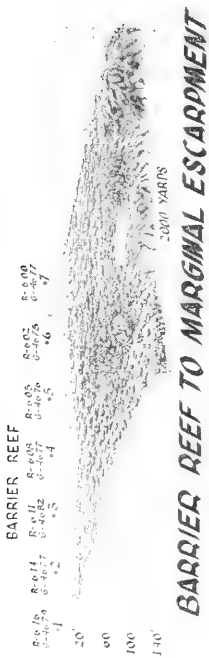
PLATE 28. DRAWINGS SHOWING MAJOR FEATURES ALONG THE SHALLOW WATER SURVEY TRACKS.

A graphic presentation of the major shoreline, lagoon, reef, and outer (seaward) platform features of the sites studied is presented in Plate 28. Although a detailed survey of the lagoon off Fresh Creek is not presented, it is almost identical to the survey off Salvador Point. Salient characteristics of the areas studied are as follows:
